# **Different scenarios of energy renovation and their returns in the city of Lausanne**

MAS EPFL  
Expertise dans l'immobilier  
2018 - 2022

Federico FABBIAN

Swiss Real Estate Institute, Zurich  
Best of research  
23 nov. 23

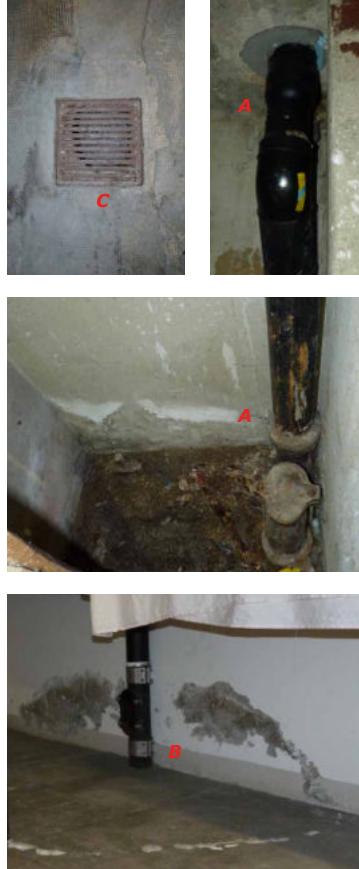
**Sous-sols**  
14 - Evacuation EC EU au sous-sol

**Type:**  
Evacuation EC EU

**Description:**  
Évacuations EC du toit et des balcons, en PVC, raccordé au sol à conduits métallique qui datent de la construction de l'immeuble (A). Évacuations EU en PVC avec portillon de regard (B). Grilles métalliques d'évacuation au sol (C).

**Etat de dégradation:** **a b (c) d**  
Les tubes en PVC sont en bon état. Les raccords à la dalle ne sont pas réalisés correctement, et avec matériel non conforme. L'évacuation des EC, au sol, ne se fait pas correctement, les anciennes conduites seraient bouchées ou percées (A). Carbonation rayonnante autour du conduit EU (B) au sol et au mur, ce qui laisse imaginer la présence de fuites. Grilles au sol oxydées mais apparemment pas bouchées (C).

**Travaux nécessaires:** **(1) 2 3 4**  
Planifier avec un ingénieur sanitaire des sondages caméra aux conduites EC et EU pour déterminer ou confirmer la cause des dégradations constatées. Un projet ad hoc sera rédigé sur la base des résultats des sondages.  
*Voir également les fiches d'obsolescence, protection incendie (ref. 3.3 - A), dangers naturels, substances nocives (ref. 3.3 - E).*

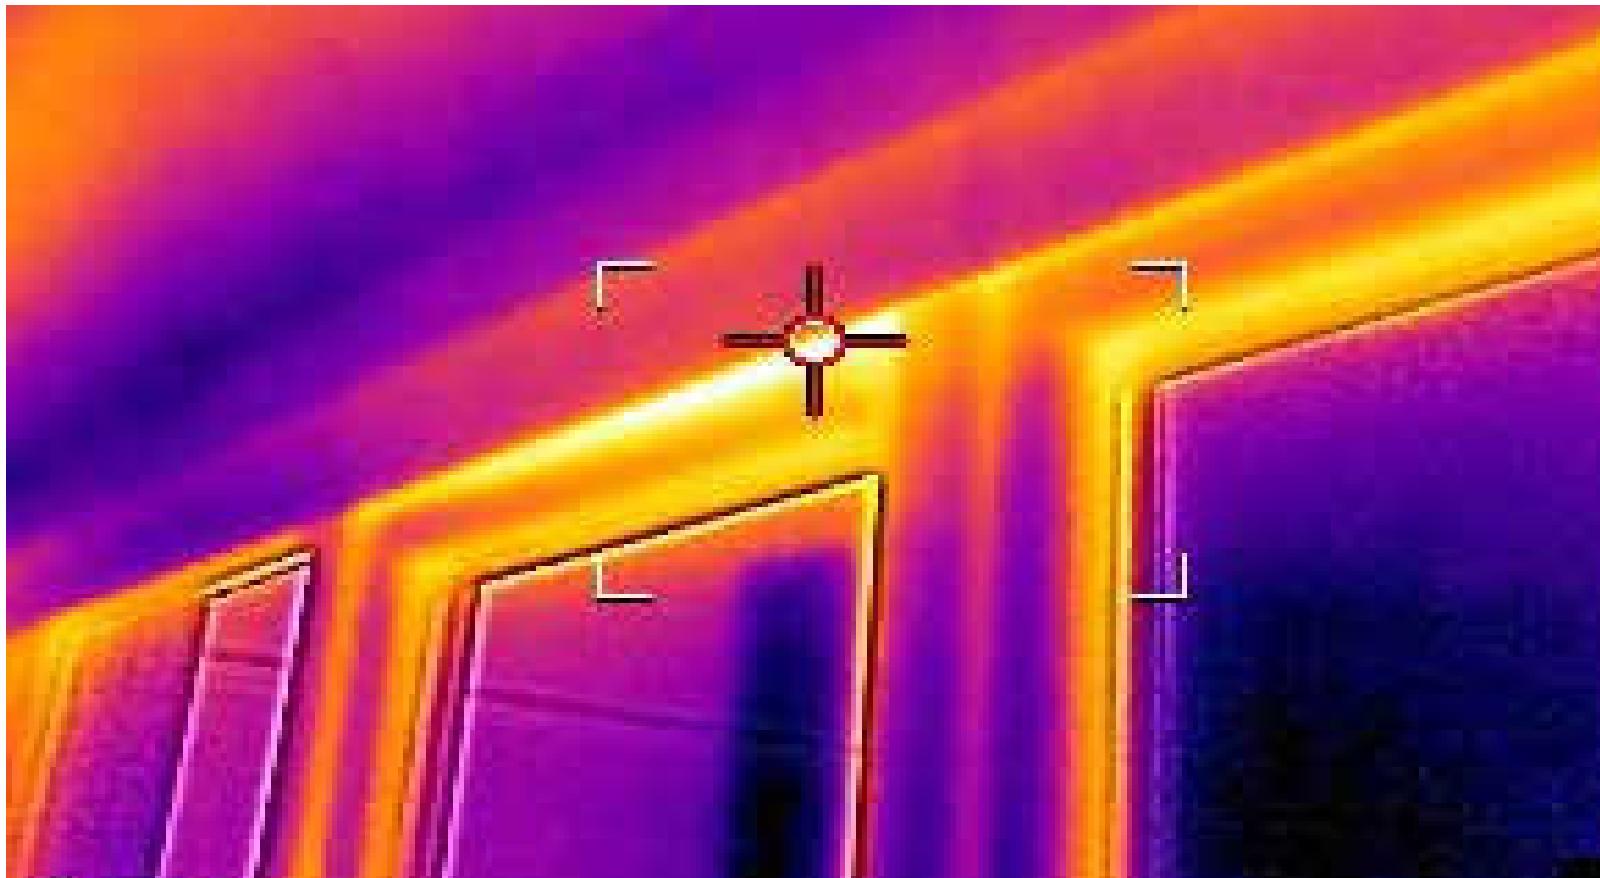
Example of window examined from the outside.  
Warm air (yellow) exits through the blind boxes producing significant heat loss.

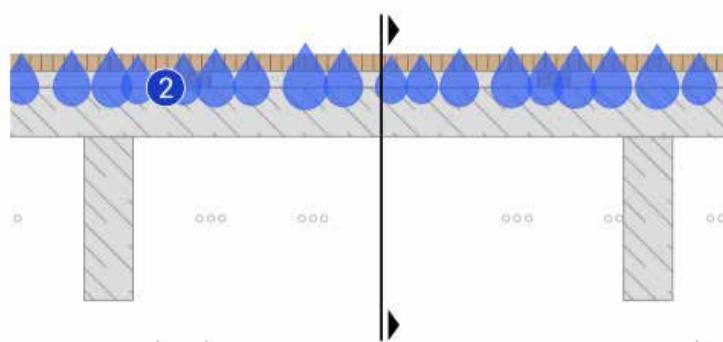
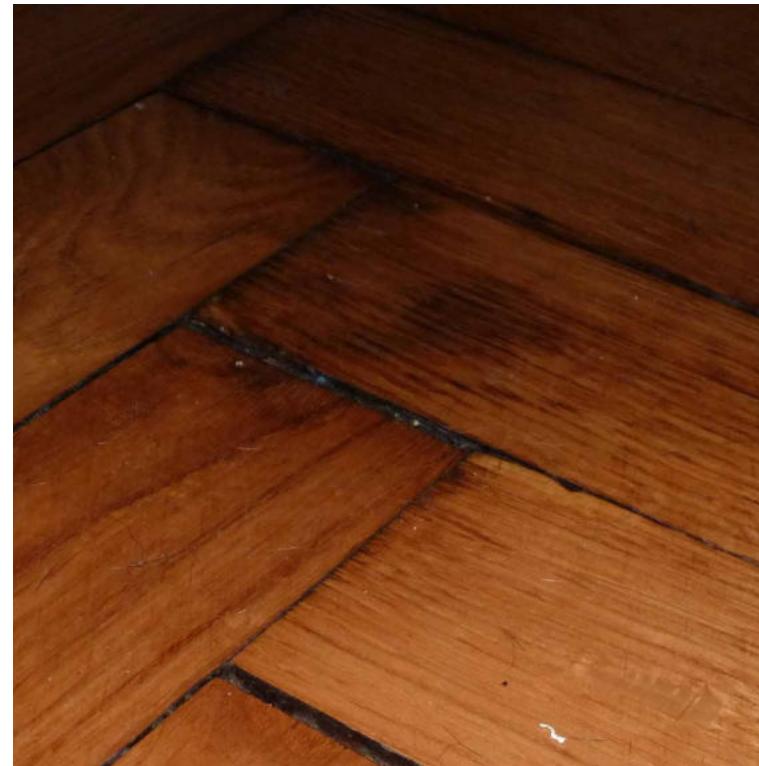
Floor between the cellars and the ground floor apartments.  
Example of condensation and mold.

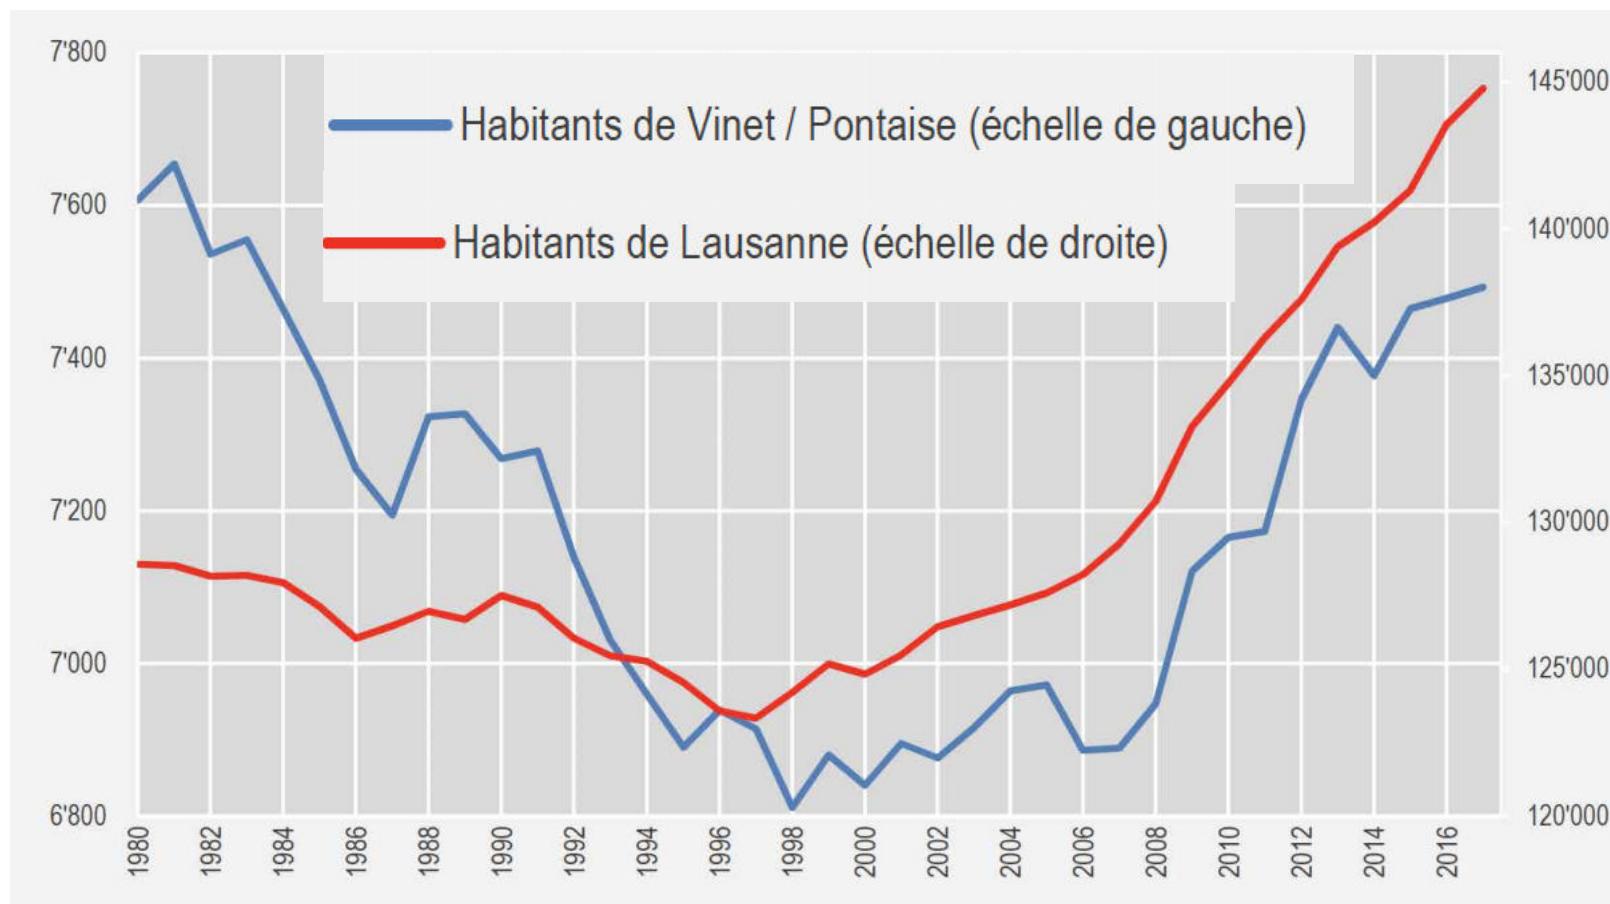
Increasing of inhabitants in Pontaise neighborhood et in Lausanne between 1980 and 2018. ([www.lausanne.ch/statistiques](http://www.lausanne.ch/statistiques), 2018)

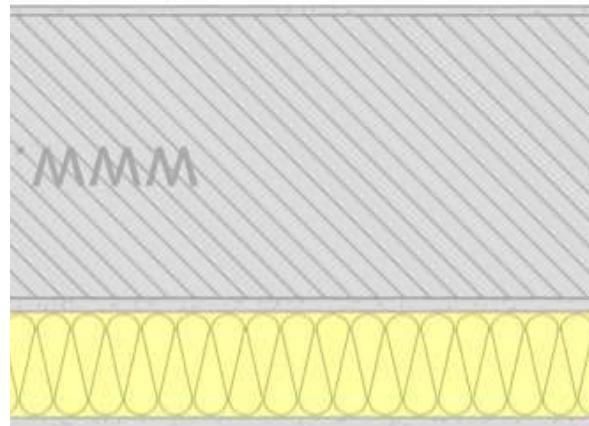
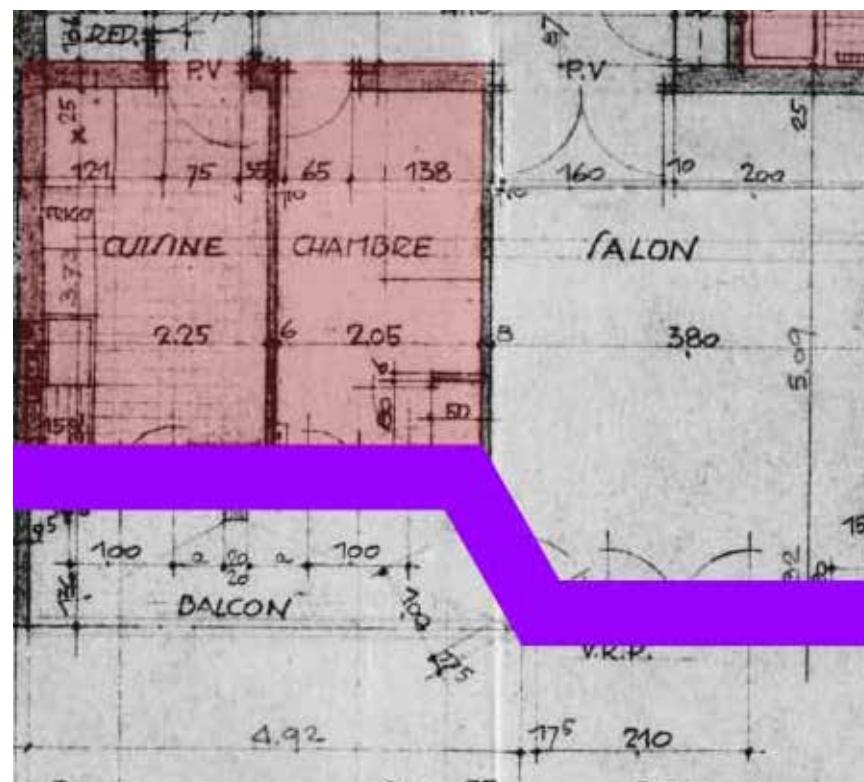
##### **Scenario 1 : ENERGY** **Improving the building's thermal envelope**

Global external insulation: 12 cm

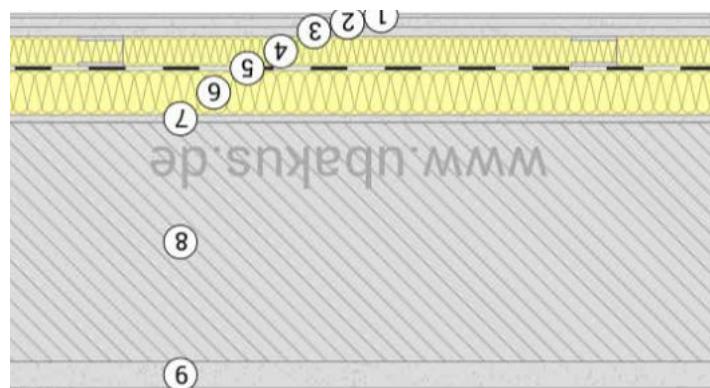
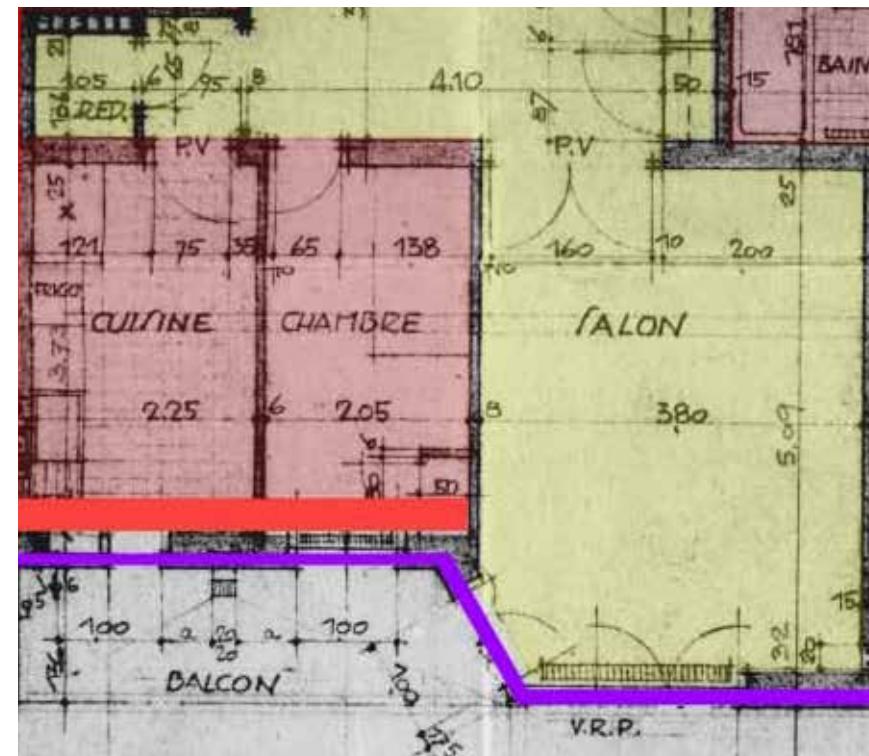
##### **Scenario 2 : ENERGY + HERITAGE**

**Improving the building's thermal envelope taking in account the building's heritage qualities**

Global external insulation : 4 cm  
Ponctual intern insulation: 10 cm

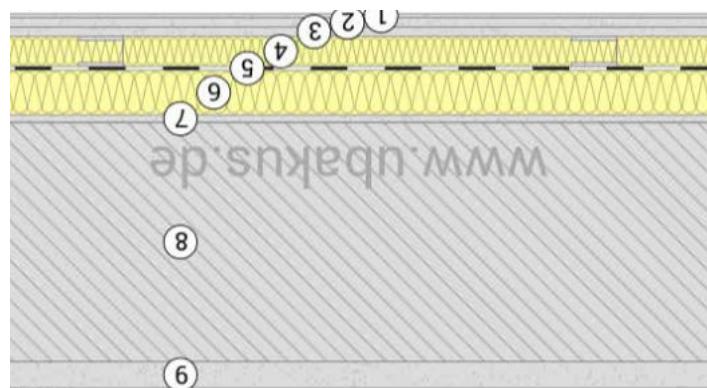
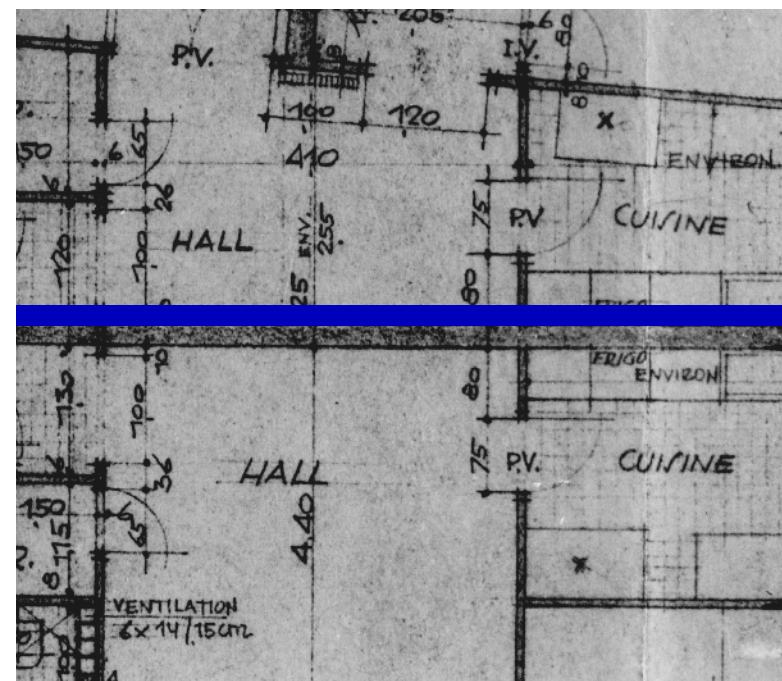
##### **Scenario 3 : ENERGY + HERITAGE + COMFORT**

**Improving the building's thermal envelope taking in account the building's heritage qualities and a general improvement in users comfort**

Global external insulation : 4 cm  
Ponctual intern insulation: 10 cm

Sound insulation between apartments  
int.
